# Experimental Analysis on the Interface Bond Strength Between Old and New Concrete

## Abstract

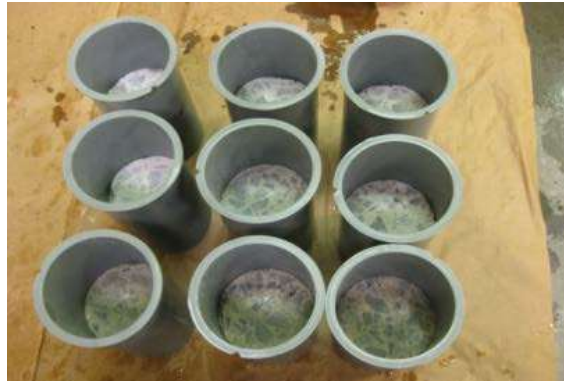
Fig. 2: Cylindrical specimen of substrate concrete inside the forms

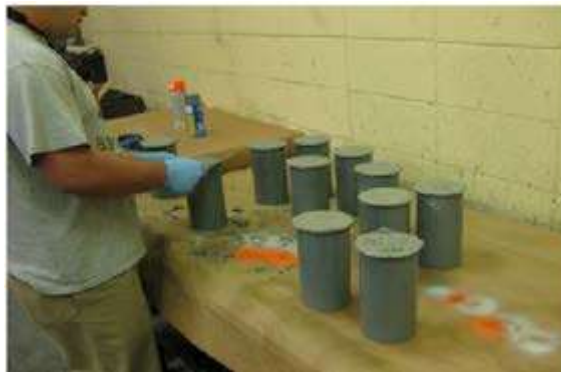
Fig. 3: Cylindrical specimen for overlay concrete
